**Tenmile River Assessment**
Shoreline Survey and Action Plan
January 2006

Tenmile River Stream Team Report

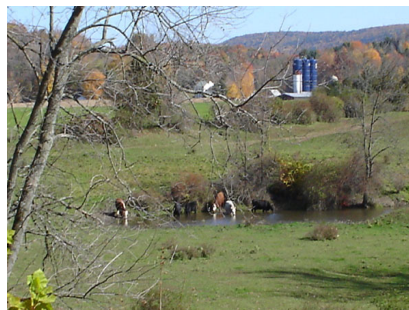
Farm along Tenmile in Dover Plains

Agricultural properties should be encouraged to reduce the amount of run-off that enters the river from their fields. Townships need to play a key role in water quality protection. They can do this by passing watershed protection ordinances and administering enforcement. This provides assurance and protection for the surrounding homeowners that rely on groundwater supplies for drinking water.

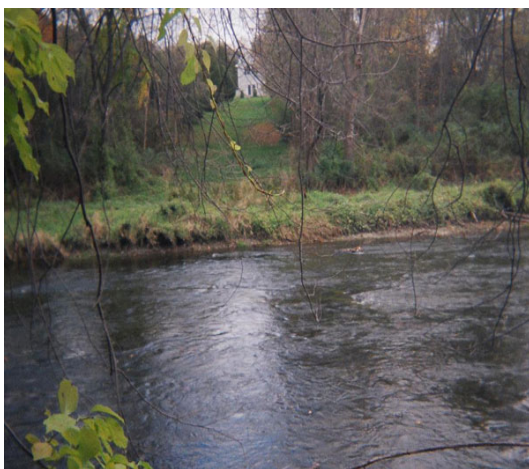
In a few places, homeowners have cut down trees in the riparian zone and have mowed down to the edge of the river. This is a common practice along most of the river and could be remedied by an education program for riparian zone restoration. The cutting is probably to improve the residents' view of the river.

Houses close to the river

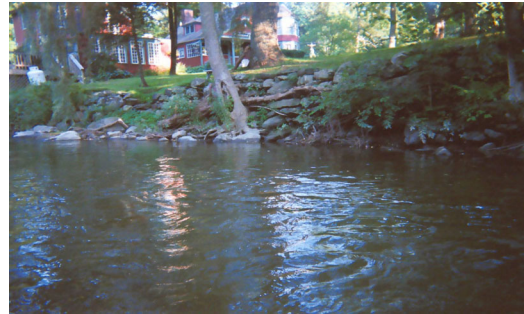
Webatuck Crafts Village

- Work with Crafts Village to restore riparian zone.
- Clean up trash.
